**MIAMI-DADE COUNTY
PERFORMANCE TEST REPORT**

MAZE NAILS

**PRODUCTS: Roofing Nails
TYPE: Galvanized**

Report No: F8657.01-106-18

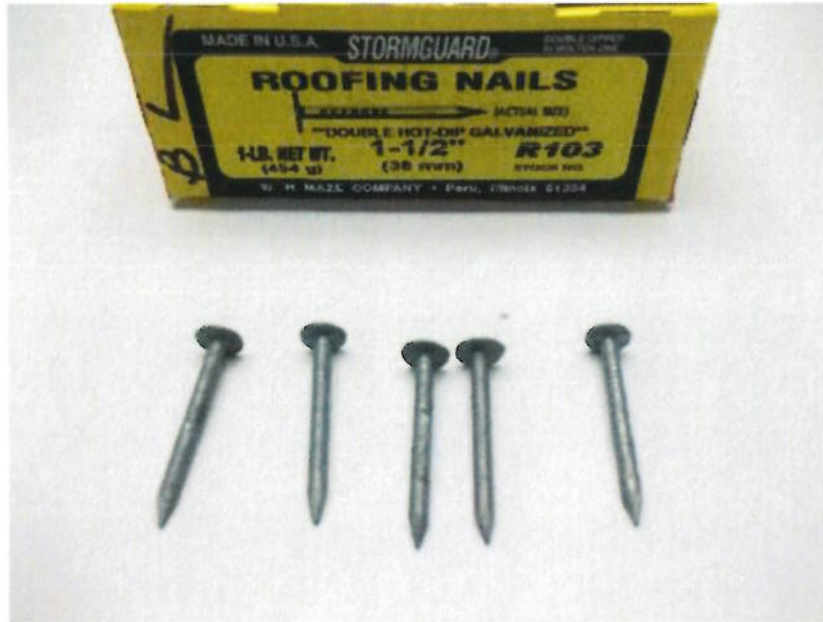
Photo No. 1

0.120" x 1-1/2" R103 Smooth Shank Roofing Nails Prior to Salt Spray Exposure

0.120" x 1-1/2" R103 Smooth Shank Hot-Dip Galvanized Hand Drive Roofing Nails

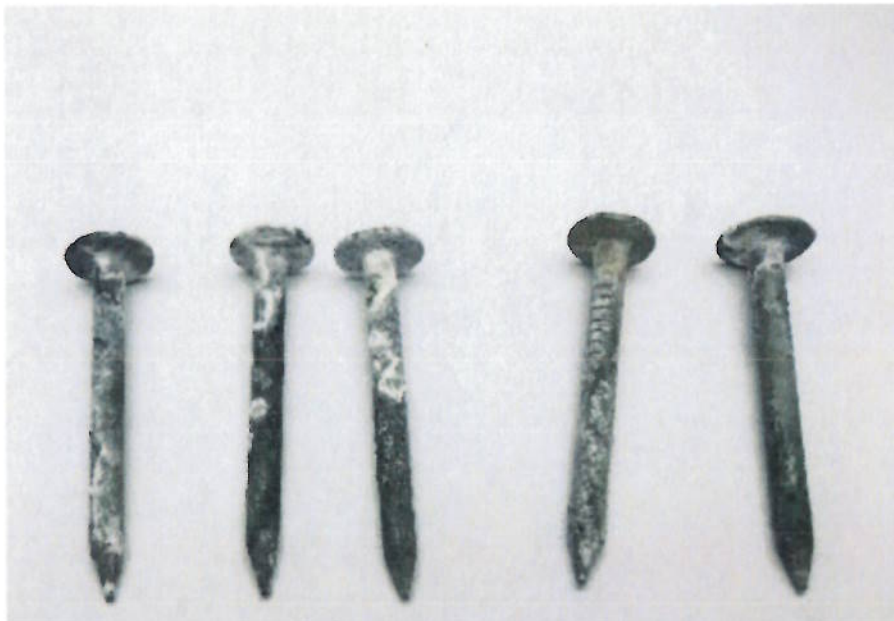
Photo No. 2

0.120" x 1-1/2" R103 Smooth Shank Roofing Nails After Salt Spray Exposure

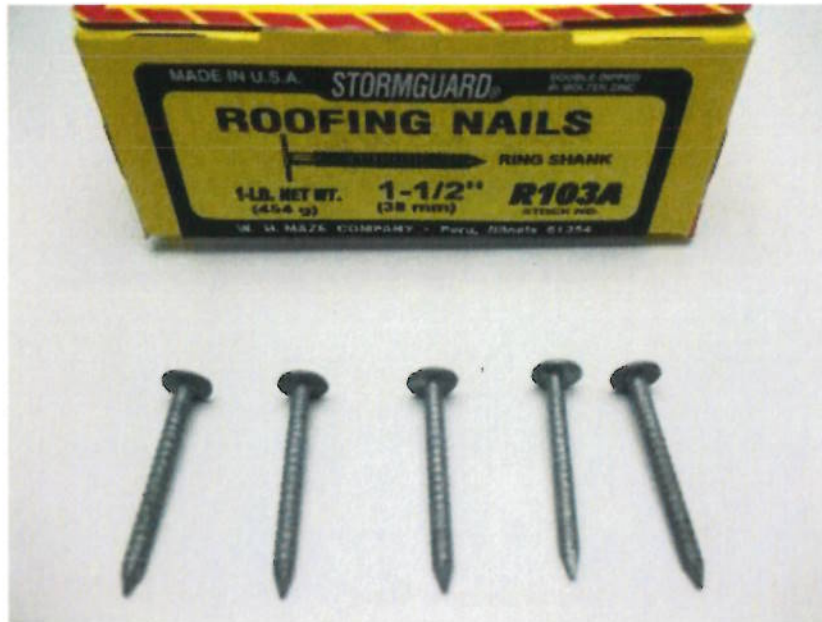
Photo No. 3

0.120" x 1-1/2" R103A Ring Shank Roofing Nails Prior to Salt Spray Exposure

0.120" x 1-1/2" R103A Ring Shank Hot-Dip Galvanized Hand Drive Roofing Nails

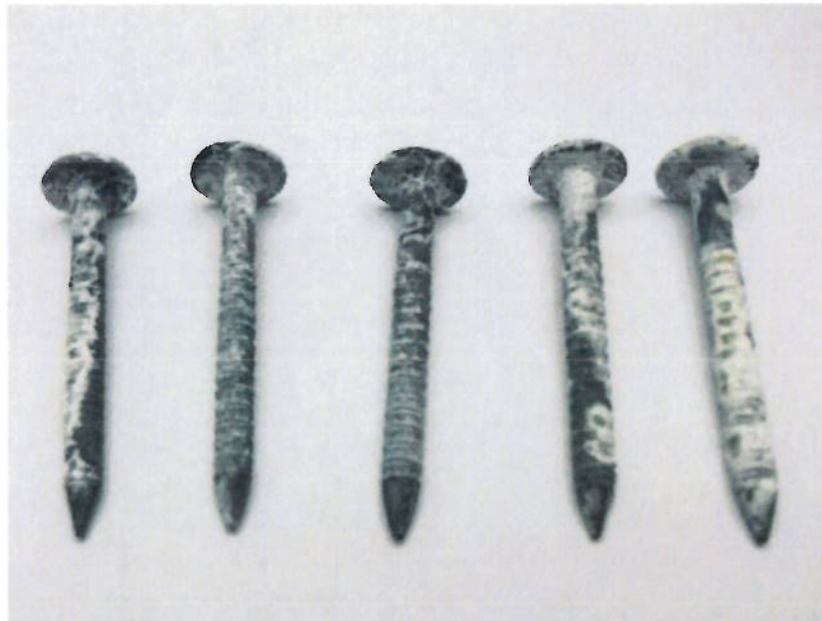
Photo No. 4

0.120" x 1-1/2" R103A Ring Shank Roofing Nails After Salt Spray Exposure

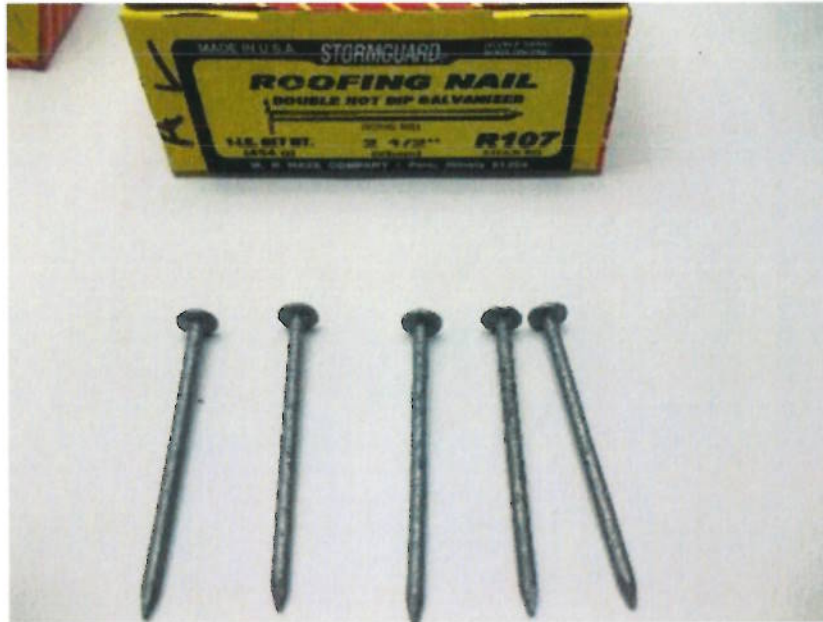
Photo No. 5

0.120" x 2-1/2" R107 Smooth Shank Roofing Nails Prior to Salt Spray Exposure

0.120" x 2-1/2" R107 Smooth Shank Hot-Dip Galvanized Hand Drive Roofing Nails

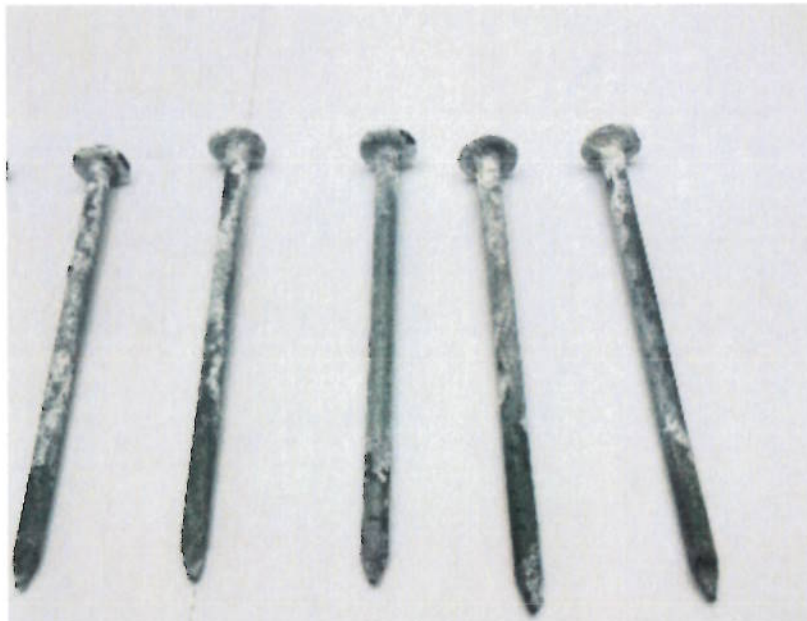
Photo No. 6

0.120" x 2-1/2" R107 Smooth Shank Roofing Nails After Salt Spray Exposure

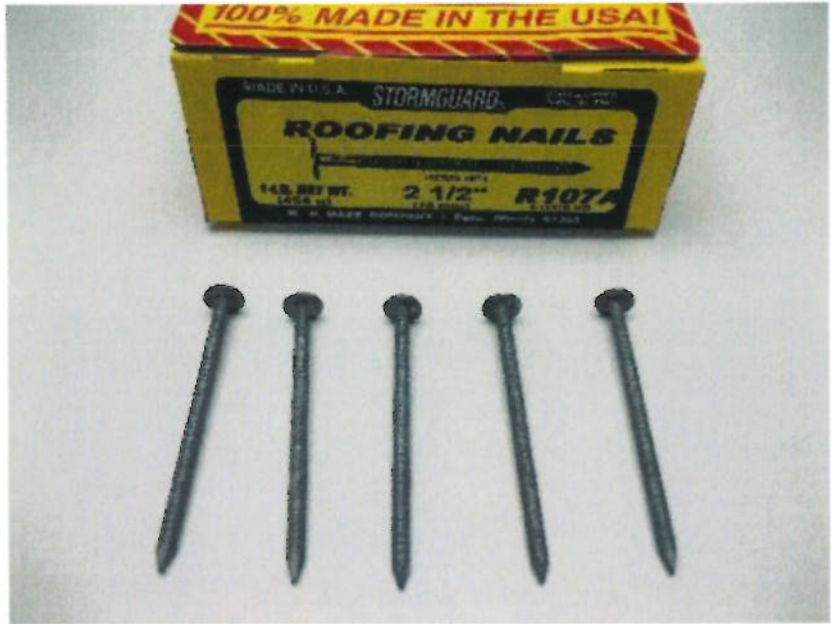
Photo No. 7
0.120" x 2-1/2" R107A Ring Shank Roofing Nails Prior to Salt Spray Exposure

0.120" x 2-1/2" R107A Ring Shank Hot-Dip Galvanized Hand Drive Roofing Nails

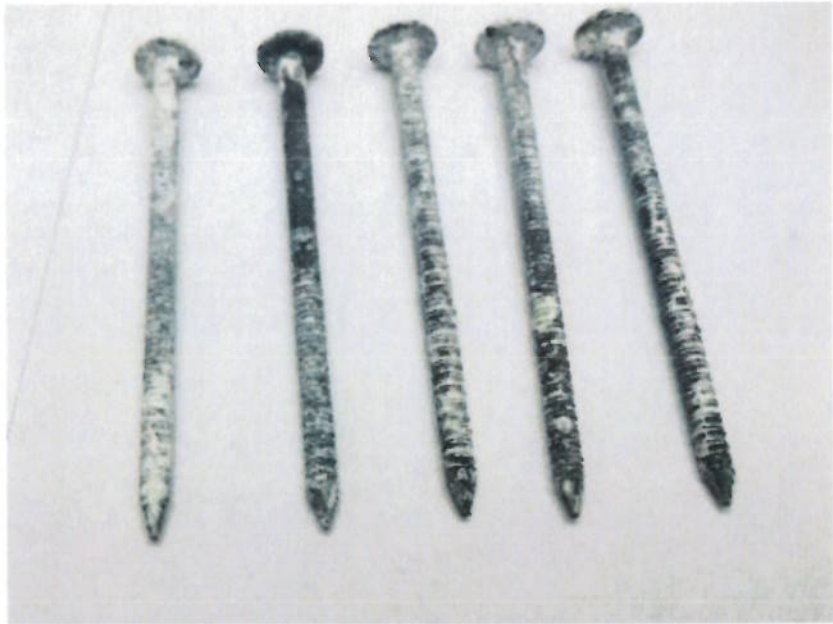
Photo No. 8
0.120" x 2-1/2" R107A Ring Shank Roofing Nails After Salt Spray Exposure

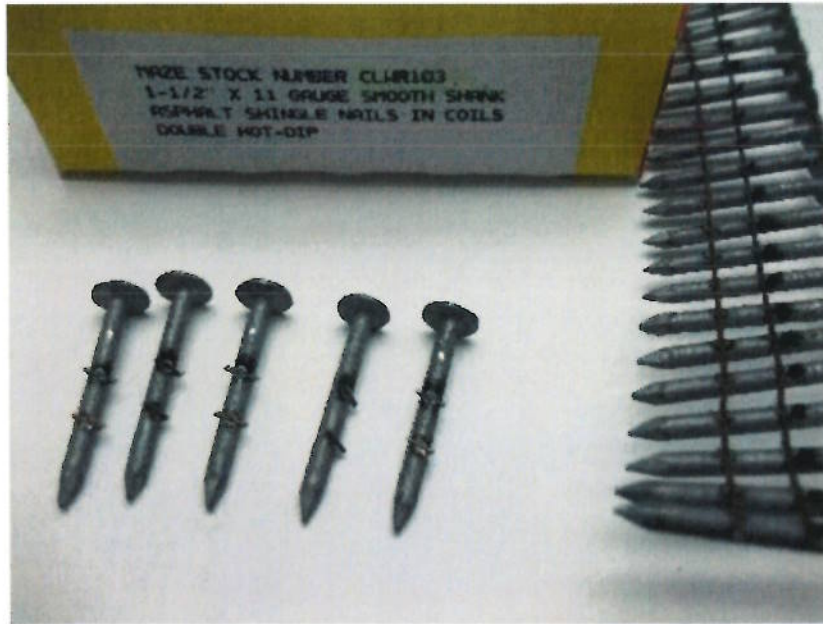
Photo No. 9

0.120" x 1-1/2" CLWR103 Smooth Shank Coil Roofing Nails Prior to Salt Spray Exposure

0.120" x 1-1/2" CLWR103 Smooth Shank Hot-Dip Galvanized Coil Roofing Nails

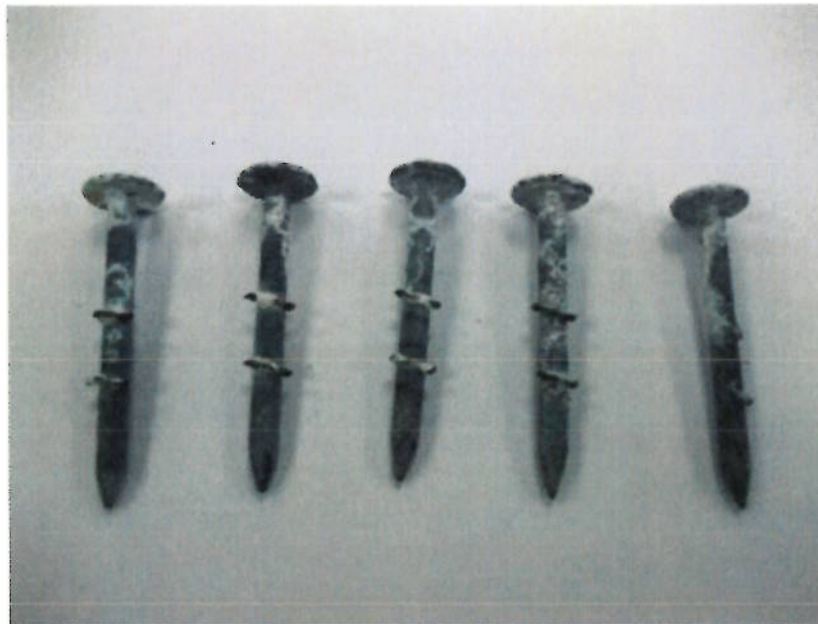
Photo No. 10

0.120" x 1-1/2" CLWR103 Smooth Shank Coil Roofing Nails After Spray Exposure

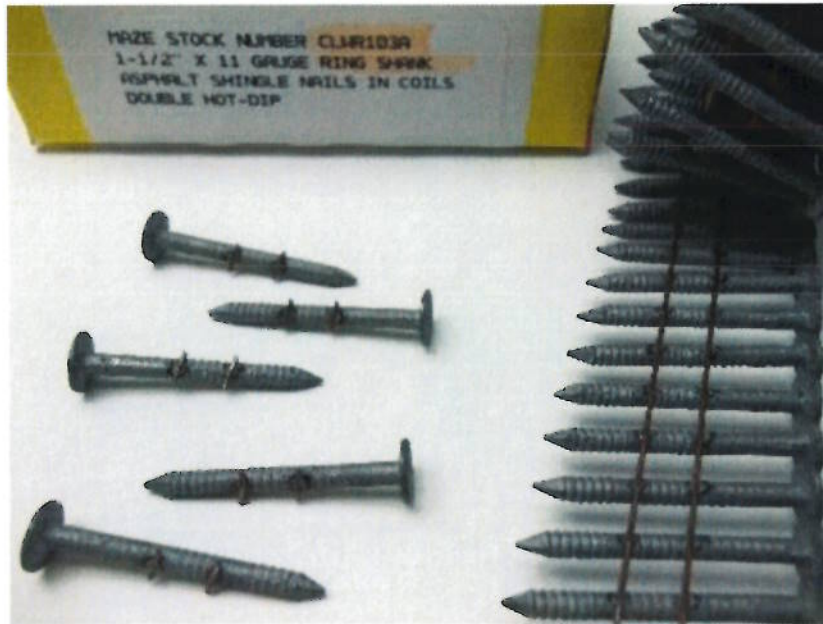
Photo No. 11

0.120" x 1-1/2" CLWR103A Ring Shank Coil Roofing Nails Prior to Salt Spray Exposure

0.120" x 1-1/2" CLWR103A Ring Shank Hot-Dip Galvanized Coil Roofing Nails

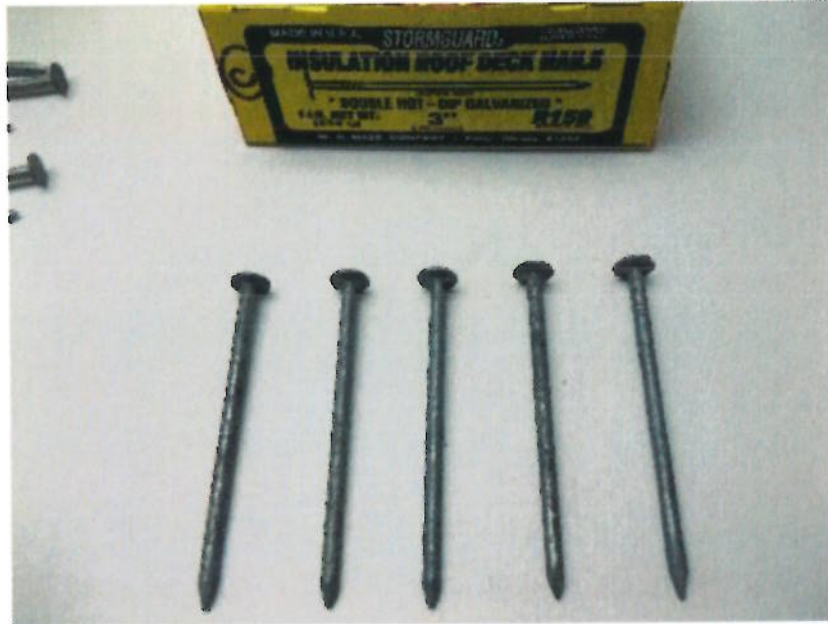
Photo No. 13

0.135" x 3" R159 Smooth Shank Roofing Nails Prior to Salt Spray Exposure

0.135" x 3" R159 Smooth Shank Hot-Dip Galvanized Hand Drive Roofing Nails

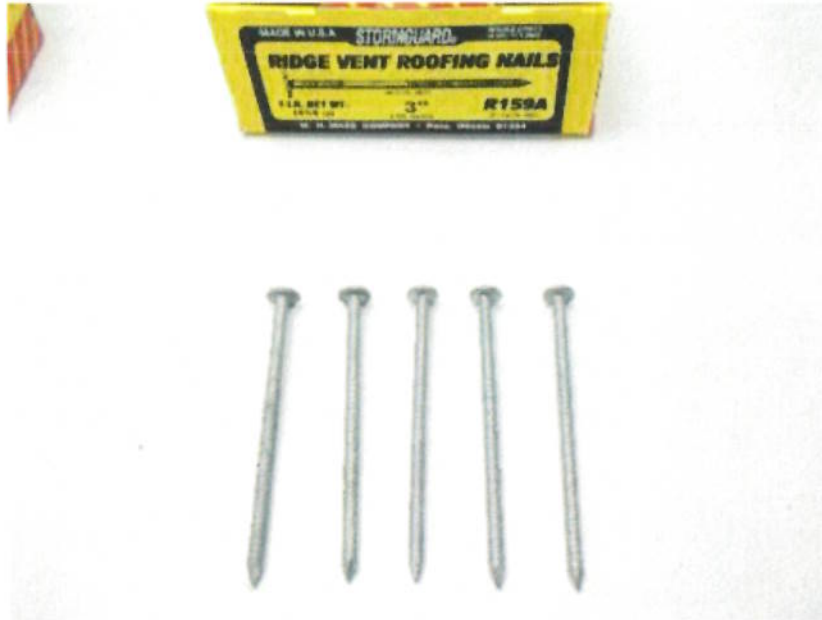
Photo No. 15
0.135" x 3" R159A Ring Shank Roofing Nails Prior to Salt Spray Exposure

0.135" x 3" R159A Ring Shank Hot-Dip Galvanized Hand Drive Roofing Nails

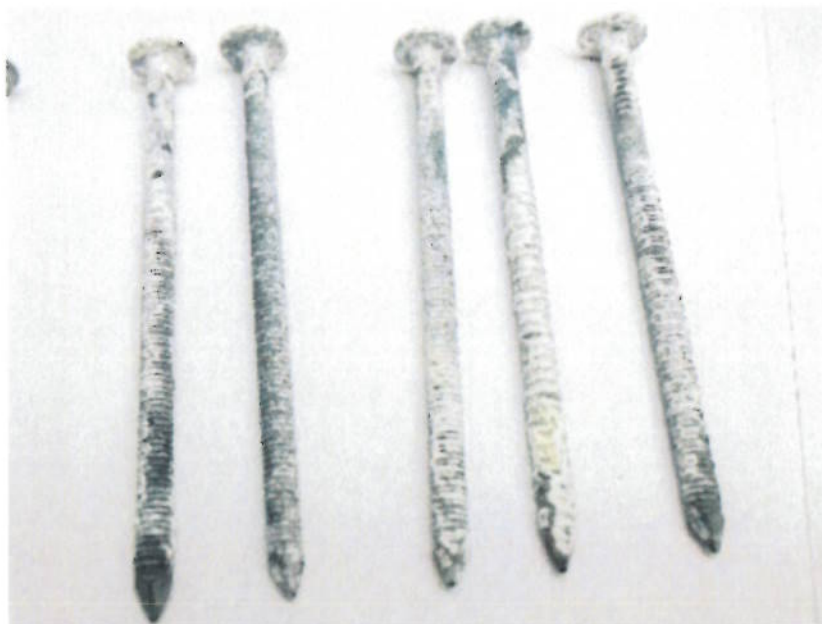
Photo No. 16
0.135" x 3" R159A Ring Shank Roofing Nails After Salt Spray Exposure
